Manhole Inspection Summary

Manhole # S15C__004MH

Insp Date: **9/15/09 2:10 PM**

Location Address: **2525 FRANKLIN ST**

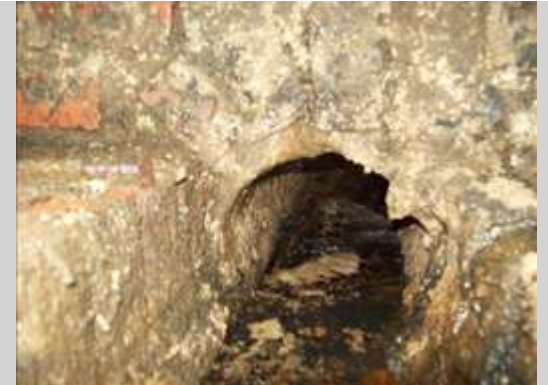
12 O'Clock Outflow

8 in. Circular Gravity Sewer
Pipe Out @ 12 O'Clock

Pipe Height: (in.) Direct
Pipe Material: **Clay** ☐ Pipe Lined
Invert Depth: **7.45** (ft.) Flow Characteristics: **Slow**
Deposits: ☒ None ☐ Mud ☐ Sludge ☐ Debris ☐ Grease
Silt Depth: (in.) Deposits Extent:
Infiltration: **None** Pipe Seal Cond: **Sound**

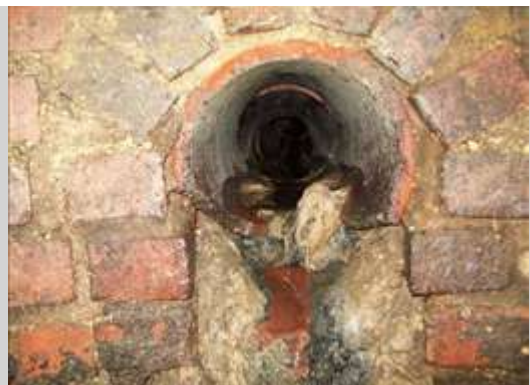
9 O'Clock Inflow

8 in. Circular Gravity Sewer

Pipe In @ 9 O'Clock

Infiltration: **None** Pipe Seal Cond: **Sound**
